Explosion at Blast Furnace

Evelyn Joos
EPSC Technical Meeting Rotterdam

21/4/2026

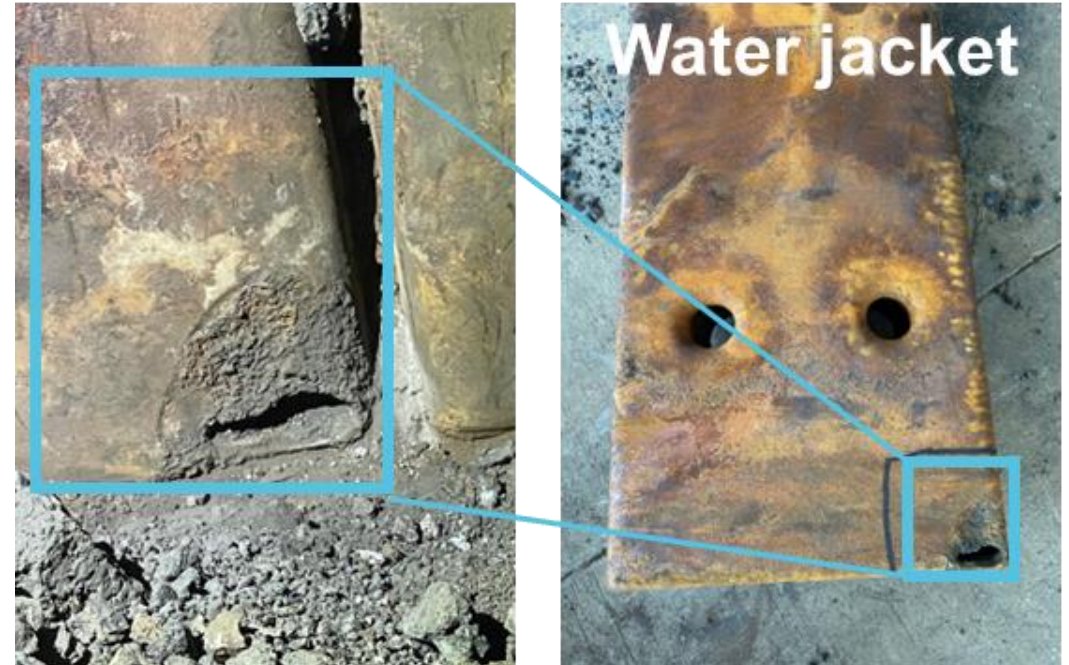
Wear of cooling plates

- Extreme temperatures causing **martensite transformation** in microstructure of cooling plates → **embrittlement**
- Fluctuations in bath height due to drops in counter pressure resulting in contact of Pb-alloy/matte phase with cooling plates → **corrosion**

- MOC to increase height of the liquid bed
- Check on magnetism for incoming Iron scrap
- Segregation of iron scrap from different suppliers (traceability and quality control)
- Mix deliveries of iron scrap from different suppliers
- Replacement of cooling water by a mixture of MEG/water – reduces impact

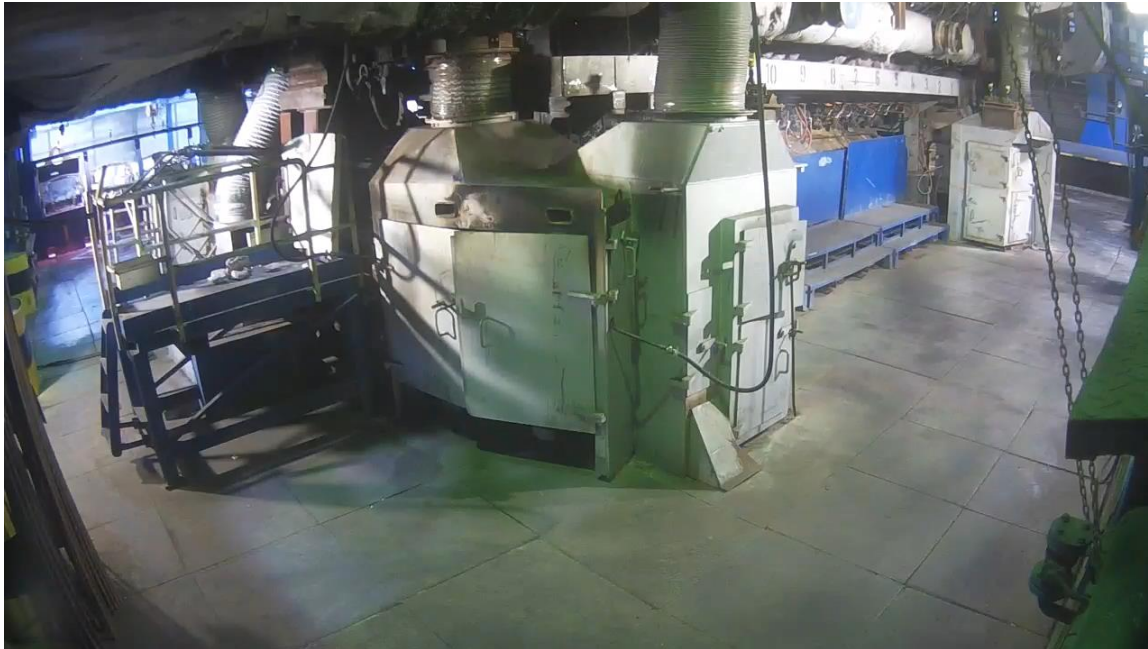
2 Explosion of cooling plate due to reaction of cooling water and liquid metals

Wear of cooling plates 1

Cooling water enters furnace

Steam explosion due to reaction water with liquid metals

- Martensite formation made cooling plates **brittle**
- Small corrosion leak was **easily enlarged by brittle cooling plates**
→ large amounts of liquid water in the oven (m³/min)
- Pressure build-up due to rapid expansion of water (1700 times volume)
- → **explosion**
