CHEF Guide - A Summary of Historical Process Safety Incidents

A brief summary of significant Process Safety incidents which have occurred in the past 50 years is summarized. Studying historical incidents is an excellent way to learn about process safety and how to prevent similar incidents from happening again. Several of these incidents were drivers in creating process safety regulation and industry guidance and are referenced throughout this document. Included are:

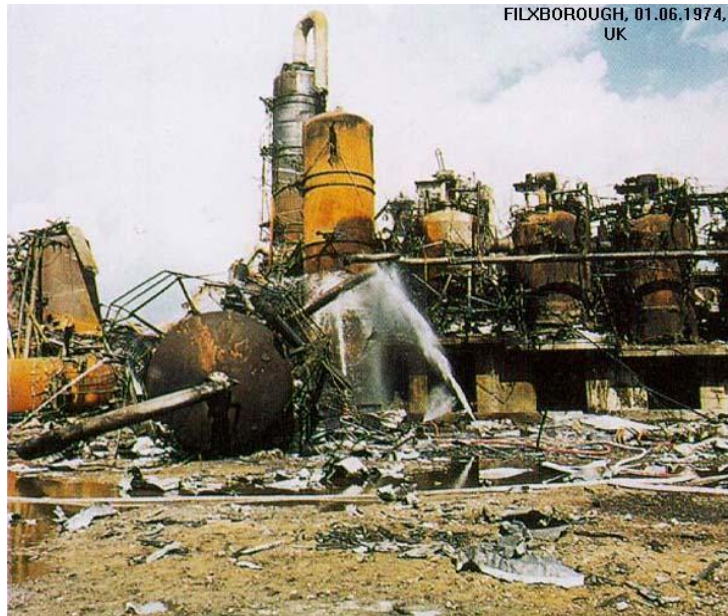
Nypro Facility, Flixborough, UK - 1974

In 1974, in a caprolactam (intermediate in the manufacture of nylon) production plant, a temporary bypass line ruptured, resulting in the leak of almost 40 tons of cyclohexane that caused a huge vapor-cloud explosion. The tragic disaster caused 28 fatalities including all the employees working in the control room. There was the alarming possibility of more than 500 fatalities had it been a normal working day instead of the weekend. Also, widespread damage to property within a 6-mile radius around the plant was another major consequence.

One of the reactors developed a six-foot crack. Management decided to remove the vessel and replace it with a temporary pipe designed in the maintenance shop without drawings or engineering review. The pipe was held in place by scaffolding.

The temporary piping worked for about two months. However, unknown to the operators, it was causing enormous stress to the reactor bellows joints. Finally, the bellows failed, releasing hot cyclohexane which ignited.

The Flixborough explosion was a critical driver in moving process safety issues forward in the UK. As a result of the Flixborough incident, at the end of 1974, the Advisory Committee on Major Hazards (ACMH) was formed. The lessons learned from this disaster highlight the importance of Management of Change with thorough evaluation prior to any modification in process plants.

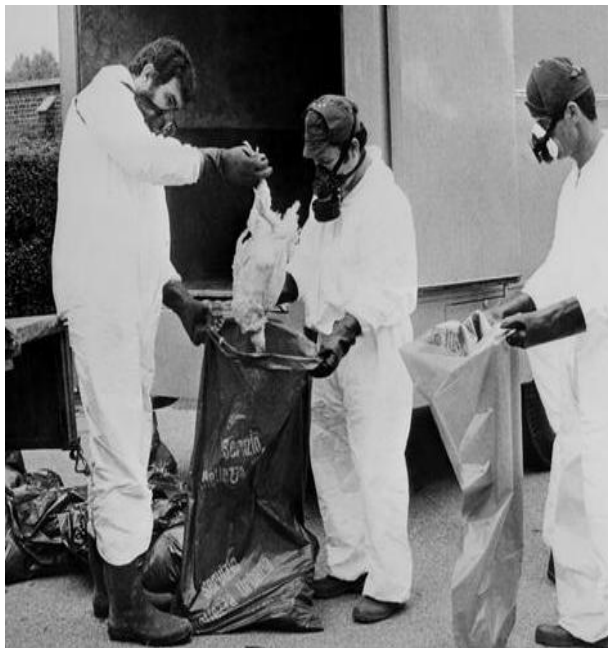
ICMESA Facility, Seveso, Italy - 1976

The Seveso disaster was an industrial incident that occurred in 1976, in a small chemical manufacturing plant approximately 25 km north of Milan. During preparation for a weekend shut down, steam temperature used for heating the reactor was greater than normal. A slow runaway decomposition began, releasing more heat and leading to the onset of a rapid runaway reaction. The reactor relief valve eventually opened, causing the airborne release of 6 tons of chemicals containing high levels of 2,3,7,8-tetrachlorodibenzodioxin (TCDD).

Because of local law, the process had to be shut down for the weekend with reactant inventory remaining in the vessel, an unusual situation. The exhaust steam pressurizing the heating coils was left on. Additionally, due to low weekend load, it reached a temperature of 300 degrees Celsius, well above its normal 190 degrees Celsius.

The reactor had no automatic cooling system; it had to be activated manually and only weekend maintenance personnel were on hand. Vessel contents reached 450 to 500 degrees Celsius, greatly increasing the formation of dioxin.

The decomposition reaction and utility operations were not known to have been covered in a Process Hazards Analysis (or PHA). Deficiencies in process design, hazard identification, and emergency response were significant (but not exclusive) contributors to the events that took place.

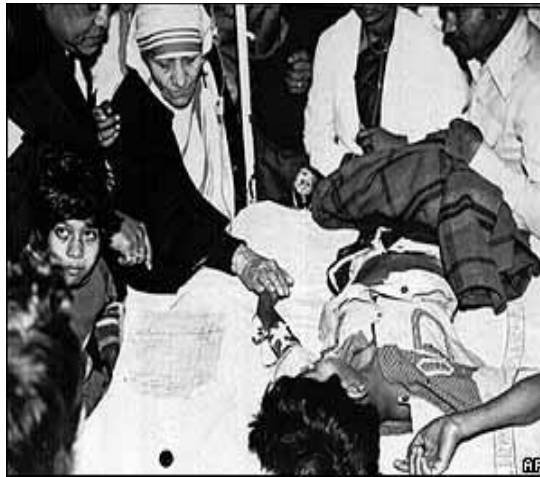
Union Carbide, Bhopal, India – 1984

In 1984, at the Union Carbide plant in India, a storage tank containing methyl isocyanate (MIC) was contaminated with water leading to a runaway reaction causing the release of more than 40 tons of toxic MIC gas through a relief valve. The incident caused more than 3,000 fatalities and injured hundreds of thousands more. This was arguably the worst chemical industry incident in terms of people affected.

After investigation, the prevailing conclusion is that water was deliberately introduced to an MIC storage vessel through an instrument connection. MIC is extremely water reactive, and a runaway reaction ensued.

- The vessel refrigeration system was down for six months to save money; its Freon was being used elsewhere.
- A relief effluent system caustic scrubber was inactive (said to be down for maintenance).
- The downstream flare for a scrubber was also shut down (said to be awaiting replacement of corroded pipe work).
- A fixed water curtain used to absorb MIC vapors was insufficient to reach the cloud.
- Supervision was slow to react to initial reports of MIC odor in the area; this was coffee break time (up to an hour may have been lost here).
- A shanty town had been allowed to form along the plant perimeter over a number of years.
- An effective emergency communication/response system was not in place.

In most of Bhopal's causal factors, you can see glaring deficiencies in the major process safety management elements of hazard analysis, mechanical integrity, operating procedures, and management of change.

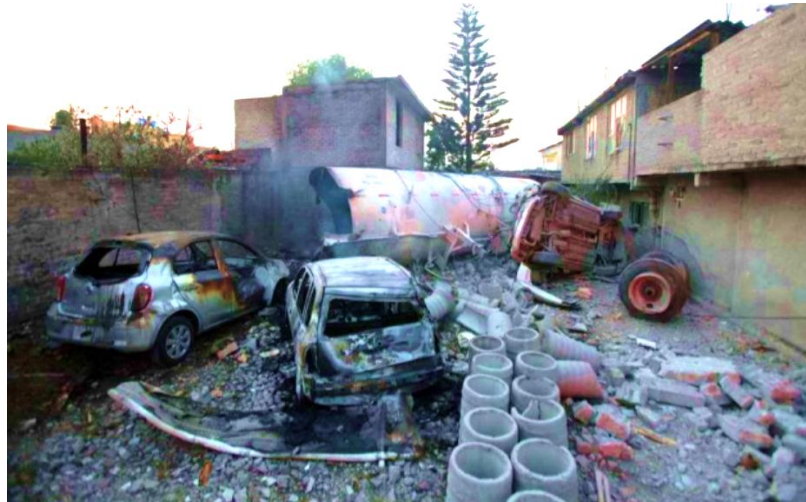
PEMEX LPG Facility, San Juanico, Mexico – 1984

The PEMEX Mexico City liquefied petroleum gas (LPG) facility had six spherical storage tanks and 48 smaller horizontal cylindrical tanks. In 1984, a leak occurred at this LPG terminal.

The LPG leak continued for five to ten minutes; a cloud of LPG vapor estimated to be 200 meters by 150 meters by two meters high formed. The cloud ignited. The explosion knocked storage tanks off their supports and ruptured piping, causing more LPG to be released.

Fire impinging on the LPG tanks resulted in a series of boiling liquid expanding vapor explosions (BLEVEs), which destroyed the site. Large fragments of the tanks traveled up to 1200 meters. In addition to destroying the facility, the fire and explosions caused 600 fatalities and injured nearly 7000 others.

Thermal radiation from the BLEVE fireball was a major cause of loss of life. Most of the casualties were members of the public living in surrounding communities that were outside the facility boundary watching the incident unfold.

- The emergency response was inadequate to remove the local population from hazards inherent to the facility.
- Improved fire protection and greater spacing between storage tanks could have reduced the consequences of the event.

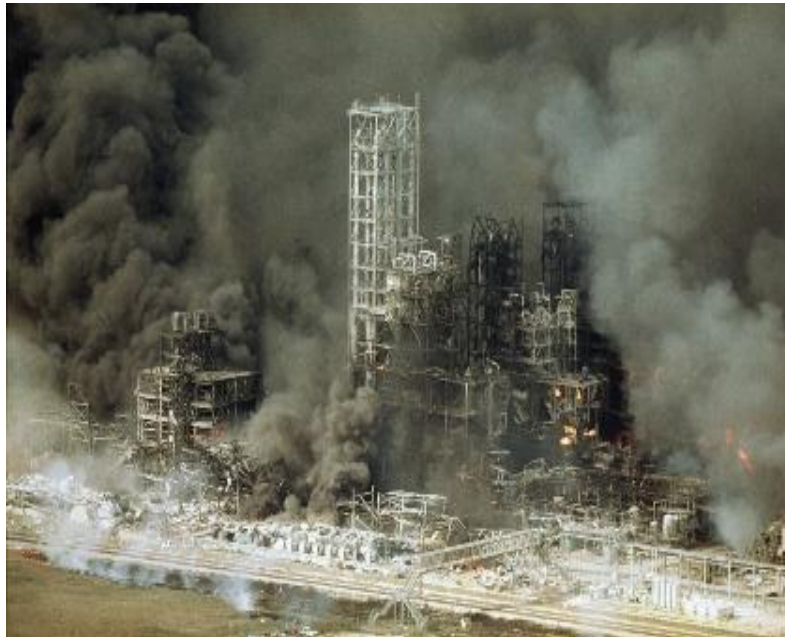
Phillips Petroleum Refinery, Pasadena, Texas – 1989

In 1989, in the Phillips Petroleum plant in Pasadena, Texas, the rupture of a seal on a polyethylene reactor caused the release of highly flammable ethylene and isobutene gas, forming a gas cloud and leading to a massive explosion. There were 23 fatalities and more than 300 injured.

Information from witnesses indicates that a vapor cloud developed very quickly and that workers had approximately 60 to 90 seconds to evacuate. The exact ignition source may never be known. Metal and concrete debris was found as far as six miles away following the explosion.

The day before the incident, a maintenance procedure had been performed by contractor personnel. This incident underscored the importance of rigid adherence to operating procedures and the implementation of an appropriate management system for contract workers. This incident also underscored the value of a thorough Emergency Plan.

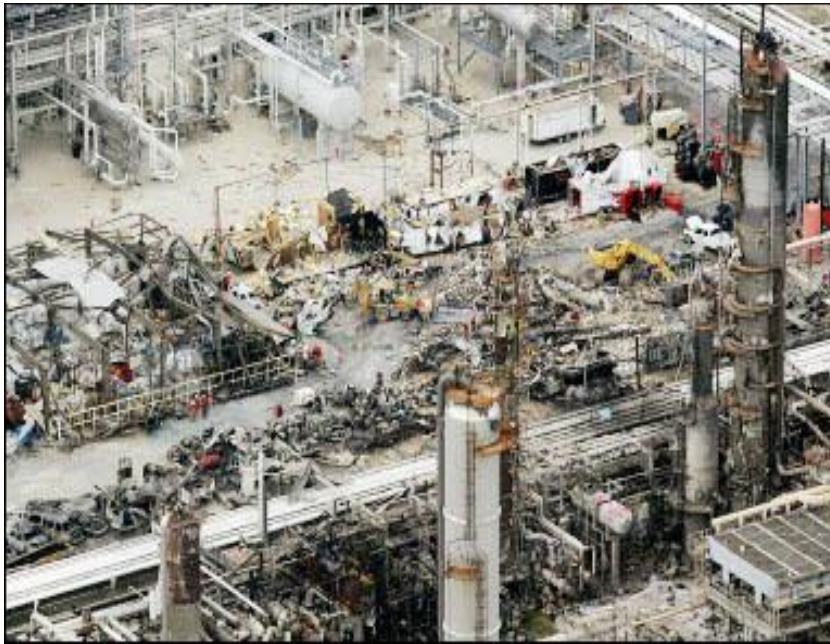
BP Refinery, Texas City, Texas – 2005

In 2005, during the startup of an isomerization unit, the safety relief valves of a distillation tower opened due to overfilling, allowing hydrocarbon liquids to flow into a disposal blowdown drum with a stack, which were also overfilled, resulting in a liquid release.

The evaporation of the hydrocarbons produced a flammable vapor cloud that ignited and led to a series of fires and explosions. Fifteen workers died and about 180 were injured. This incident led to major investigations including the milestone Baker panel report headed by former US Secretary of State James Baker III.

Trailers were used as temporary buildings by contractors at the site. Some of these trailers were located near the process. The trailers were not designed to be blast resistant. All of the fatalities occurred in or near the trailers located close to the blowdown drum.

At the time of the incident, wood frame trailers had been located 37 meters from the vent of a blowdown drum stack. The local rule for wood frame trailers was that they should be no closer than 107 meters from process equipment without an MOC review. This review had not been done.

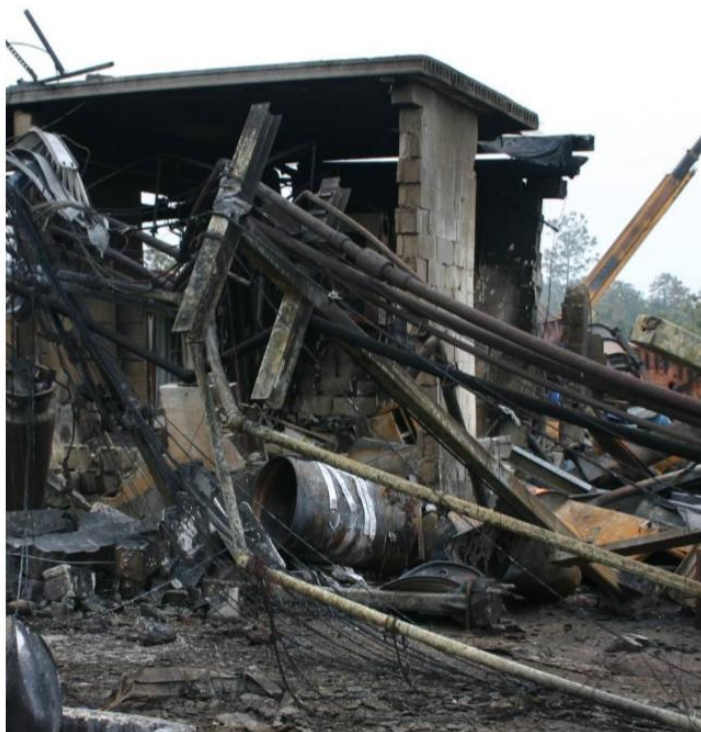
T2 Laboratories, Jacksonville, FL – 2007

In 2007, a runaway reaction resulted in a powerful explosion and subsequent chemical fire that caused four fatalities and destroyed T2 Laboratories, Inc. a chemical manufacturer in Jacksonville, Florida. 32 were injured, including the four employees and 28 members of the public who were working in surrounding businesses. Debris from the reactor was found up to one mile away, and the explosion damaged buildings within one quarter mile of the facility.

One of the most significant findings by the U.S. Chemical Safety Board (CSB) investigation was that neither the owners nor operators of the processing facility were aware of all of the potential hazards associated with the reactions in the facility. Other findings included:

- The cooling system employed was susceptible to single point failures due to a lack of design redundancy.
- The MCMT reactor relief system was incapable of relieving the pressure from a runaway reaction.

The CSB identified the root cause as “T2 did not recognize the runaway reaction hazard associated with the MCMT it was producing” and made recommendations to include process safety in the criteria that AIChE and the Accreditation Board for Engineering and Technology (ABET) uses for review and approval of chemical engineering programs.

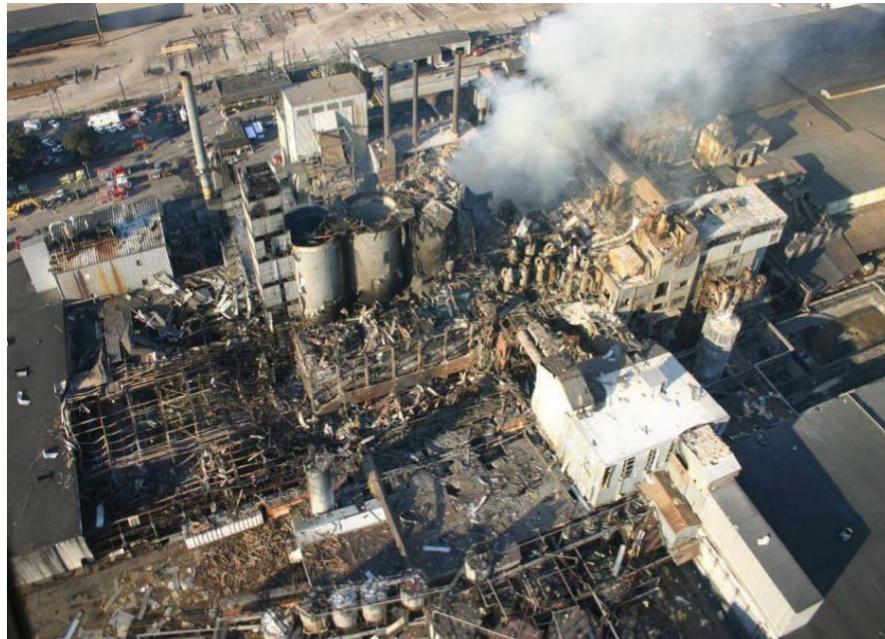
Imperial Sugar, Port Wentworth, GA – 2008

In 2008, a series of sugar dust explosions occurred at the Imperial Sugar manufacturing facility in Port Wentworth, near Savannah, Georgia. The event resulted in 14 worker fatalities. Thirty-six workers were treated for serious burns and injuries.

The explosions and subsequent fires destroyed the sugar packing buildings, palletizer room, and silos, and severely damaged the bulk train car loading area and parts of the sugar refining process areas.

A system of screw and belt conveyors and bucket elevators transported granulated sugar from the refinery to three storage silos. The CSB determined that the first dust explosion initiated in the enclosed steel belt conveyor located below the sugar silos.

The recently installed steel cover panels on the belt conveyor allowed explosive concentrations of sugar dust to accumulate inside the enclosure. An undetermined source – perhaps an overheated equipment bearing – ignited the sugar dust, causing a violent explosion. The explosion lofted sugar dust that had accumulated on the floors and elevated horizontal surfaces, propagating more dust explosions through the buildings.

Secondary dust explosions occurred throughout the packing buildings, parts of the refinery, and the bulk sugar loading buildings. The pressure waves from the explosions heaved thick concrete floors and collapsed brick walls, blocking stairwell and other exit routes. The resulting fires destroyed the packing buildings, silos, palletizer building and heavily damaged parts of the refinery and bulk sugar loading area.

This incident underscored the need to raise awareness of dust explosion hazards. It also prompted process facilities to conduct a comprehensive review of all areas where dust might accumulate to ensure

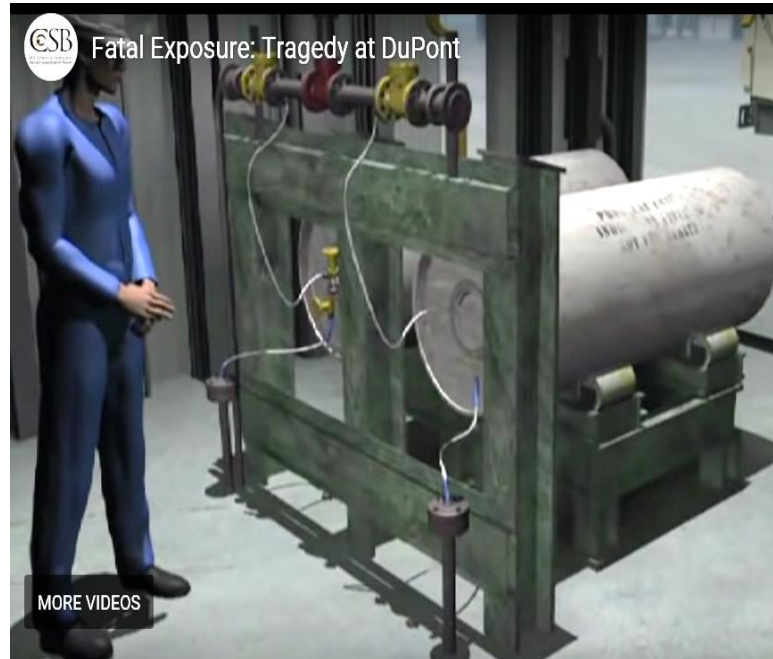
DuPont Facility, Belle, WV – 2010

In 2010, there was a release of highly toxic phosgene that caused a fatal exposure to a veteran operator at the DuPont facility in Belle, West Virginia. DuPont officials told the CSB that a braided steel hose connected to a one-ton capacity phosgene tank suddenly ruptured, releasing phosgene into the air.

- DuPont's phosgene hazard awareness program was deficient in ensuring that operating personnel were aware of the hazards associated with trapped liquid phosgene in transfer hoses.

- DuPont relied on a maintenance program that was subject to changes without authorization or review, did not automatically initiate a change-out of phosgene hoses at the prescribed interval, and did not provide a back-up process to ensure timely change-out of hoses.

- DuPont Belle's near-miss reporting process was not rigorous enough to ensure that the near failure of a similar phosgene transfer hose, just hours prior to the exposure incident, would be immediately brought to the attention of plant supervisors and managers.

- DuPont lacked a dedicated radio/telephone system and emergency notification process to convey the nature of an emergency at the Belle plant, thereby restricting the ability of personnel to provide timely and quality information to emergency responders.

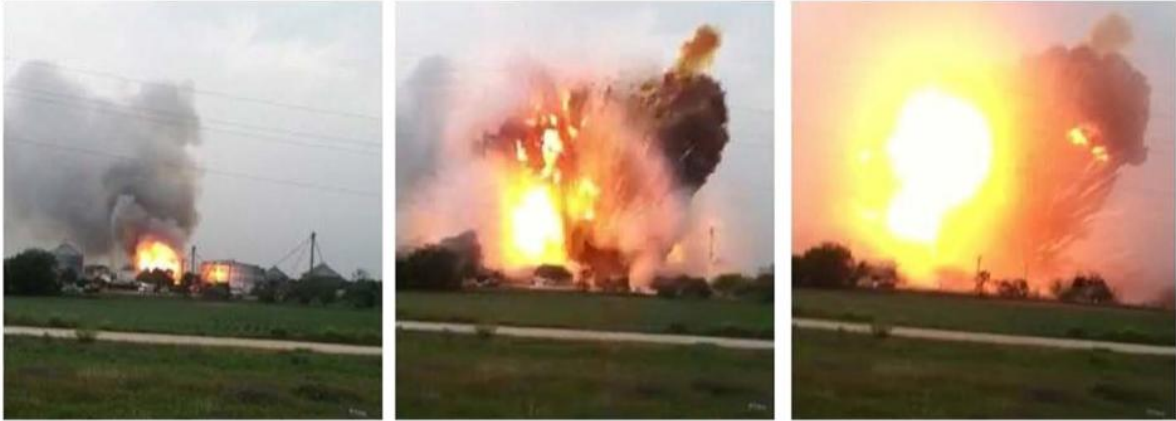
West Fertilizer Facility, West, TX – 2013

In 2013, a fire broke out in a fertilizer storage and distribution facility in the town of West, Texas. The facility stored large amounts of ammonium nitrate for use as a fertilizer. The fire caused approximately 27 metric tons of ammonium nitrate to detonate. The site itself and buildings near the site were destroyed.

The explosion caused extensive damage and destruction in the town of West. It resulted in 15 fatalities and many more injuries.

The CSB noted that the use of combustible materials next to the storage of ammonium nitrate at the site introduced the risk of a fire, which could then trigger an ammonium nitrate explosion. Twelve of the 15 people who died as a result of the incident were *volunteer firefighters* trying to evaluate the fire prior to the explosion.

One of the lessons learned from this incident is that the large volume of ammonium nitrate improperly stored at the facility created an increased risk that does not exist with an ordinary 10 or 20-kilogram bags of fertilizer.

Also, had the volunteer firefighters been better trained, managed, and informed of the quantity, proximity, and hazards of the ammonium nitrate stored at the facility, they likely would have been kept away from the fire.
