# Niederstedem Tank Explosion

EPSC Learning Sheet April 2026

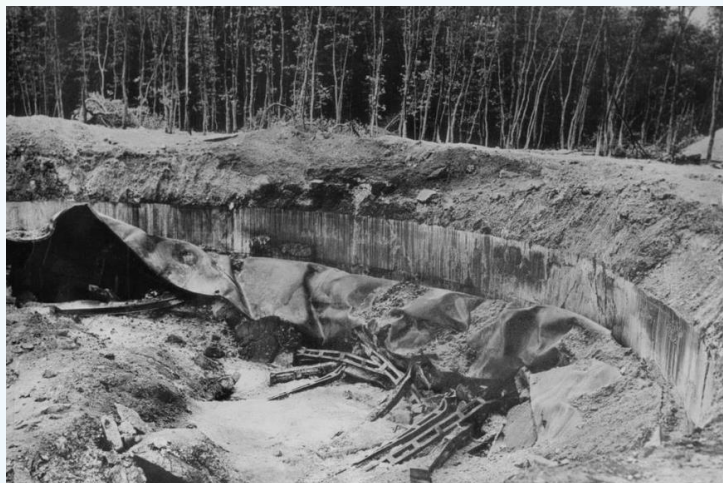
The tank containing an explosive mixture, suddenly ignited and exploded. 29 people lost their lives in the incident.

- Aircraft fuel (like Kerosine) in underground tanks, typically remains below the flame point of 37 °C. Here some light components and potentially a warm day resulted in a tank that contained an explosive mixture.
- The roof area of a storage tank that can contain an explosive mixture, is not a safe place. Limit the occupancy to essentials.
- CO<sub>2</sub> is often used in extinguishing equipment. When sprayed it can cool to -78 °C and form solid particles. These particles can become statically charged especially due to speed in (dry) air.
- When charged CO<sub>2</sub> particles get close to (grounded) metal, they can discharge and create a spark sufficient to ignite hydrocarbons. This most likely caused the explosion.

CO<sub>2</sub> as solid particles, can cause  
electrostatic discharge
