Explosion at Blast Furnace

Evelyn Joos
EPSC Technical Meeting Rotterdam

21/4/2026

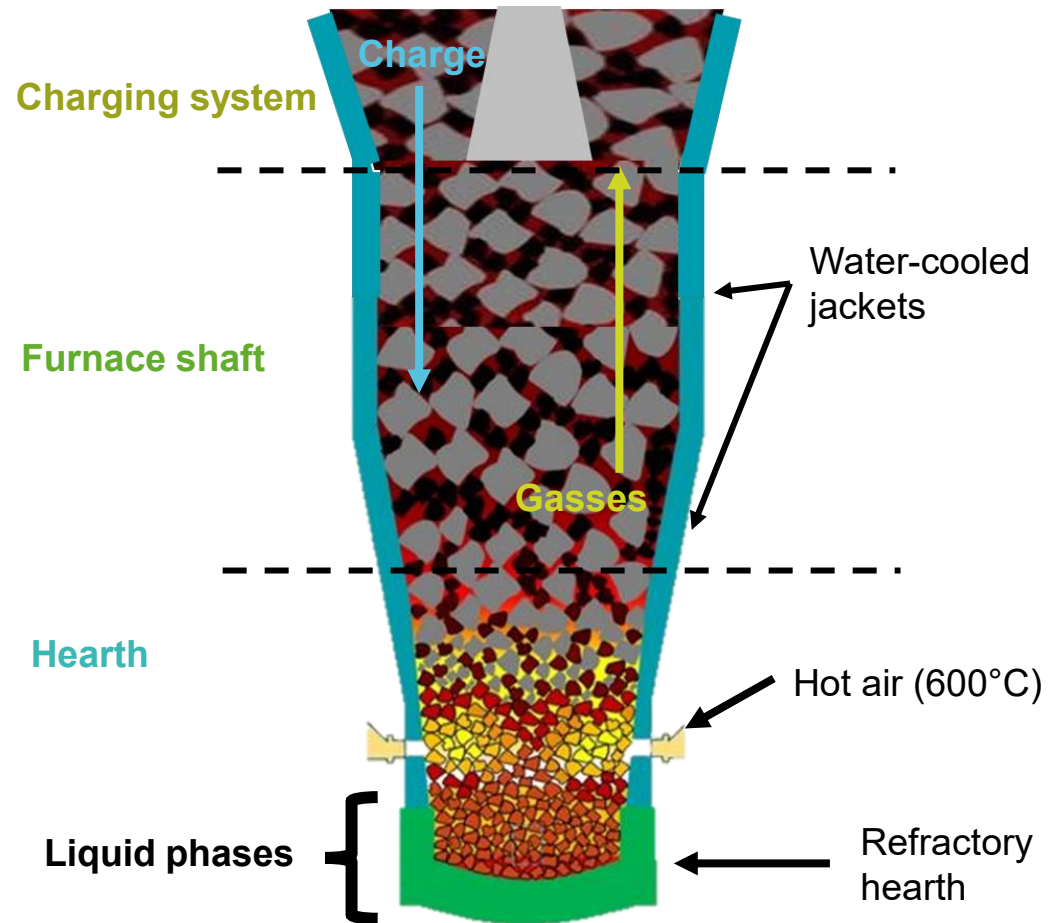
Introduction – Blast furnace process

Continuous process where lead slags are reduced to a lead bullion

- Solid feed (25°C) mainly lead slag
- Reducing agents: Cokes and **iron** scrap
- Bed needs to have sufficient strength and permeability

- Pre-heating zone (25 – 1000°C)
- Solid charge – solid cokes
- Water-cooled jackets

- Collecting liquid phases (1100 – 1250 °C)
- Refractory hearth

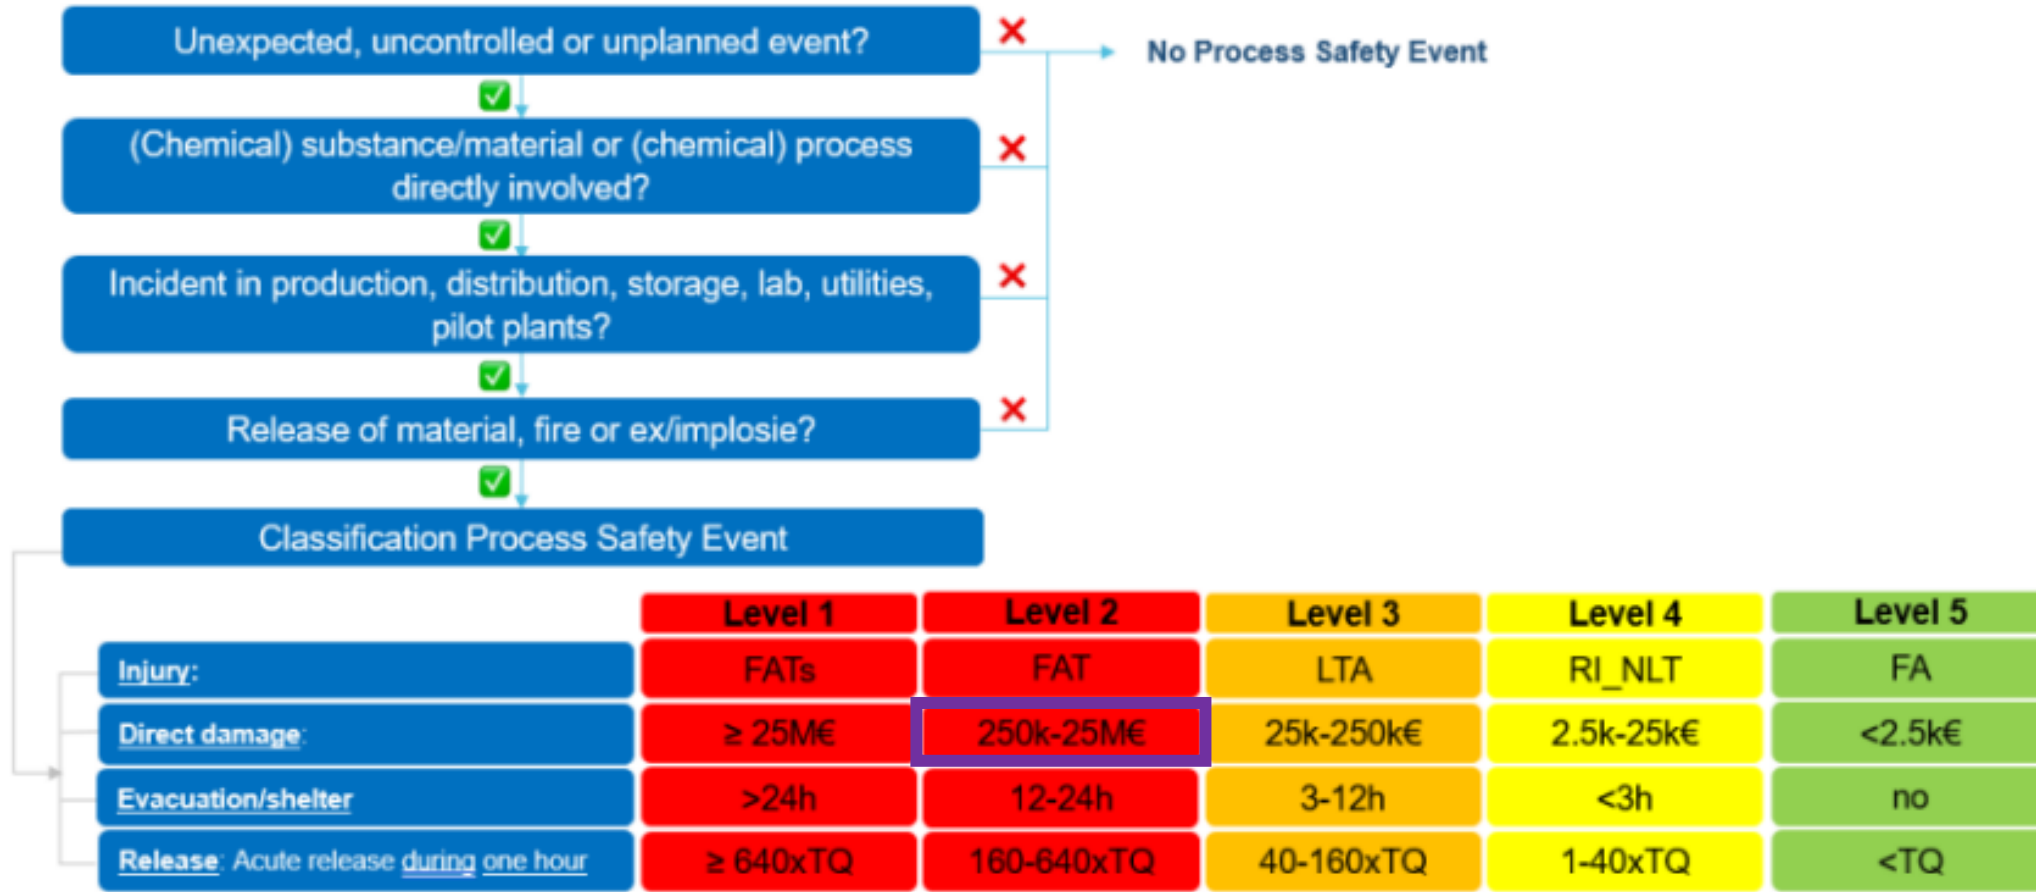
Incident classified as PSE Level 2
