2026 Calendar

A year of process safety incident case studies

A process safety training initiative

Department of Chemical Sciences
University of Limerick

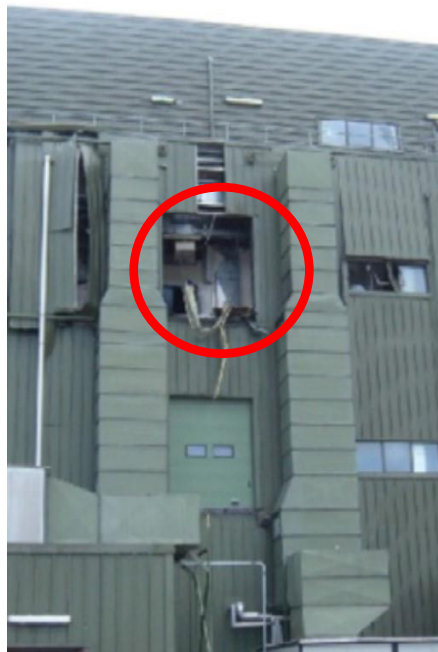
Figure 1: The north side of production Building No. 2 (PB2), post-incident, with the upper roller-shutter door missing (circled). Image source: Loss Prevention Bulletin
