Unplugging

EPSC Learning Sheet Sept 2021

In 1989 the Philips Pasadena disaster started after an ethylene release that ignited.

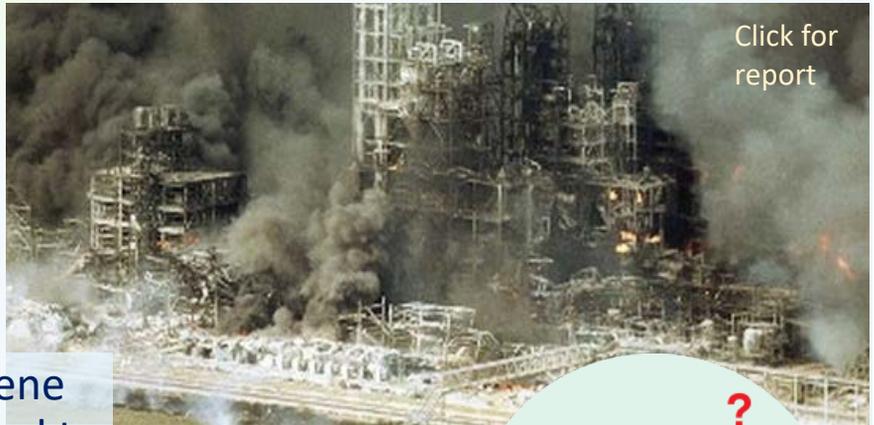
High pressure ethylene might have been used to blow out residual PE polymer from a reactor settling leg. A LOTO locked ball valve was opened to do so.

- Polymers have the tendency to plug lines that can restrict flows or block instrument lines.
- Plants generally have no good procedures to remove plugs and operators tend to become creative to avoid shut down.
- The hazards of removing plugs need to be well understood and opening of equipment to reach the plug need to be avoided or controlled by senior management.
- Do not use pressure of hazardous chemicals to de-plug pipe lines or process equipment.
- Before opening an installation to remove polymer or plugs, remove hazardous chemicals, pressure and energy.

Unplugging of equipment needs an approved plan!
